Manhole Inspection Summary

Manhole # **S15GG_014MH**

Insp Date: **9/20/07 10:32 AM**

Location Address: **1606 THOMAS AVE**

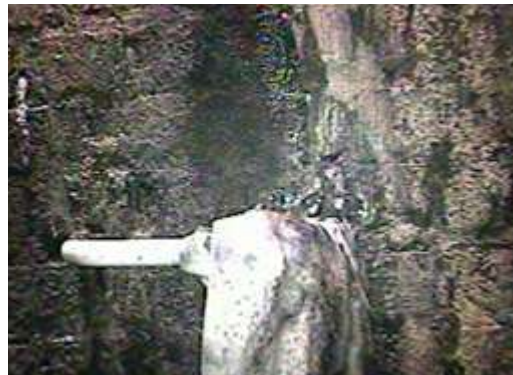
Defect 1

☒ **Evidence Of Surcharge** Depth: **3** (ft.) ☐ Active Surcharge Present

EVIDENCE OF SURCHARGE

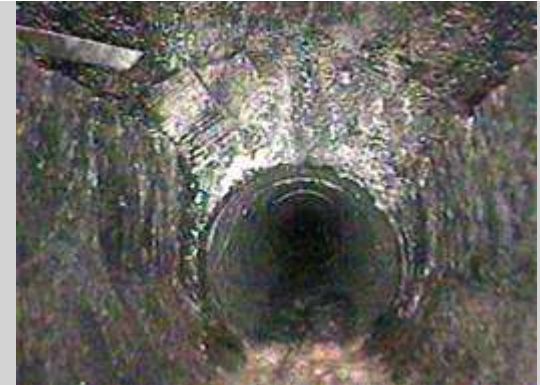
12 O'Clock Outflow

8 in. Circular Gravity Sewer
Pipe Out @ 12 O'Clock

Invert Depth: **8.66** (ft.) Flow Characteristics: **Fast**

Deposits: ☒ None ☐ Mud ☐ Sludge ☐ Debris ☐ Grease

Infiltration: **None** Pipe Seal Cond: **Unknown**

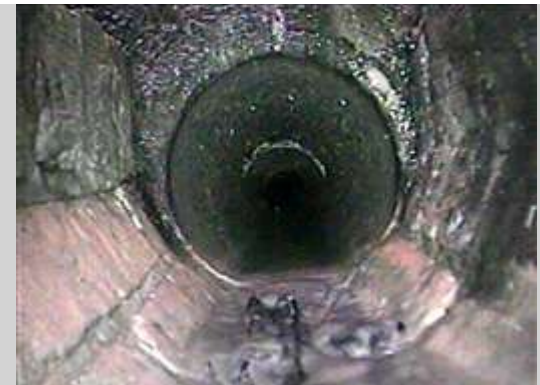
6 O'Clock Inflow

8 in. Circular Gravity Sewer
Pipe In @ 6 O'Clock

Invert Depth: **8.60** (ft.) Flow Characteristics: **Fast**

Deposits: ☒ None ☐ Mud ☐ Sludge ☐ Debris ☐ Grease

Infiltration: **None** Pipe Seal Cond: **Unknown**
